Monitoring of Forestry BMPs in Michigan Fall 2011

*Prepared by Dr. Larry Pedersen
For the Michigan SFI® Implementation Committee
April, 2012*

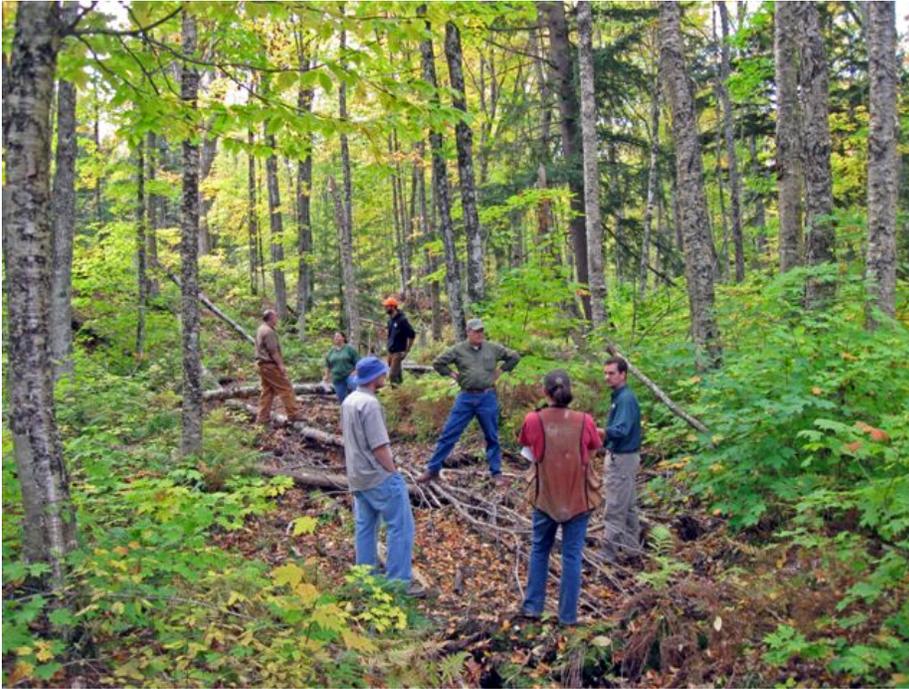
The audit team discussing RMZ management and stream classification along an intermittent stream.

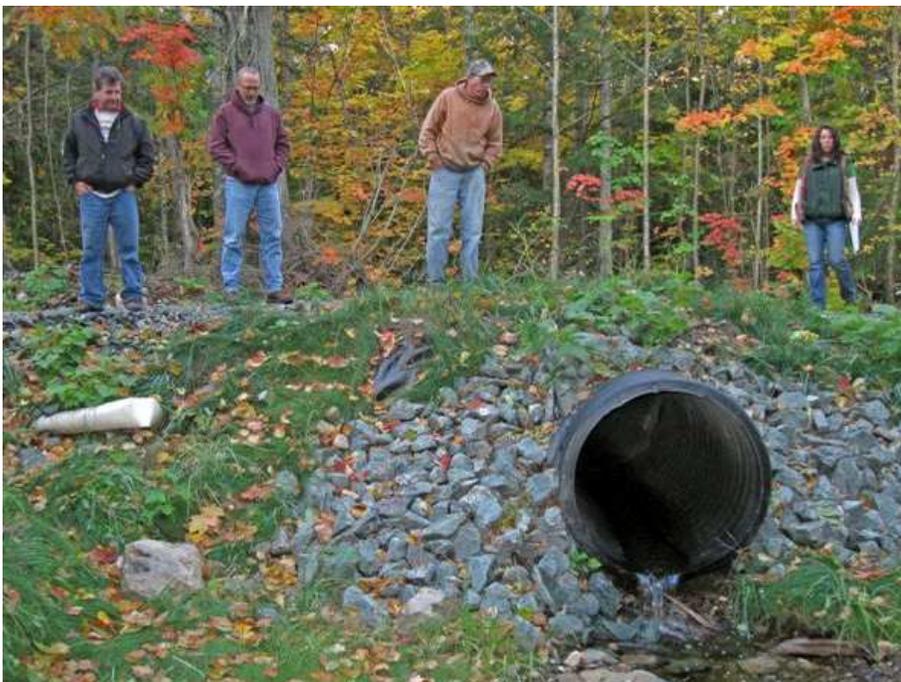
Auditors discuss perched culvert placed over bedrock.

Perched culvert – did not recess and follow permit – inadequate water diversion at 4ft culvert.

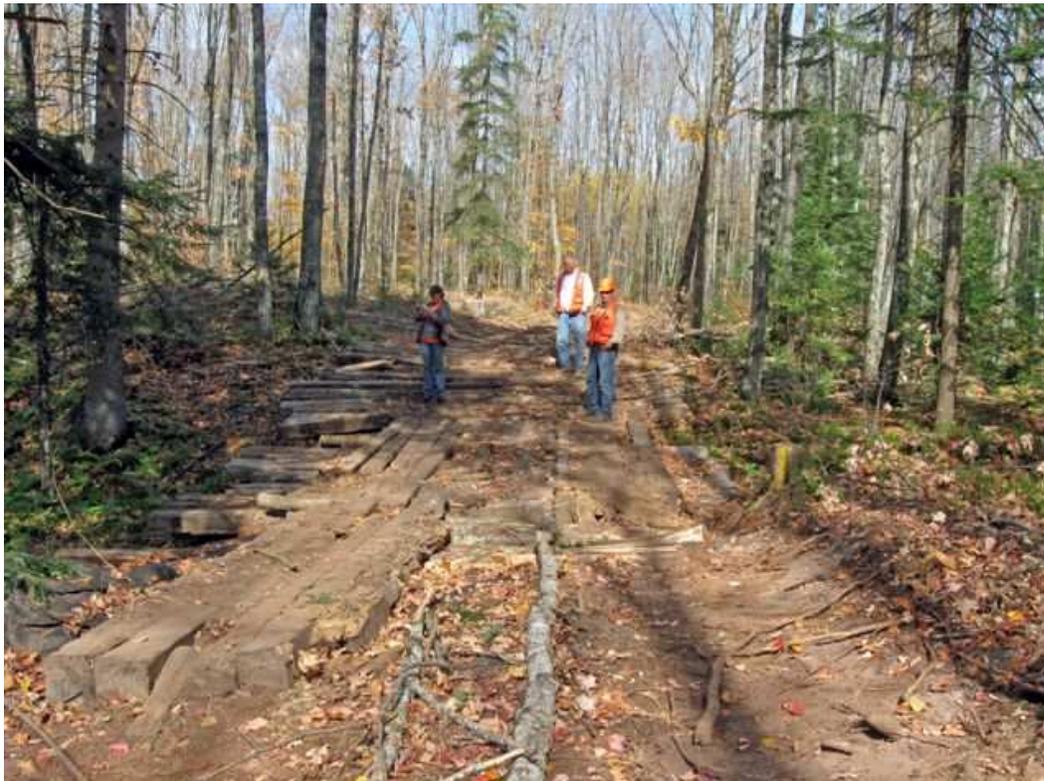
The audit team discussing use of timber mats to cross a seasonally wet area.
